## Restoration Project Description

Nissan Patrol 4W66 (First Generation) 4x4, 1960

November 2021 through March 2026

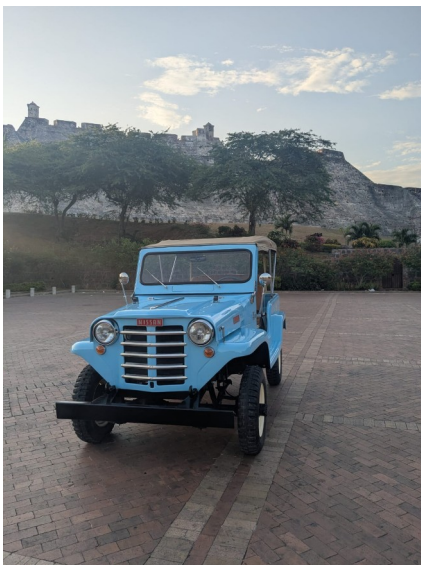
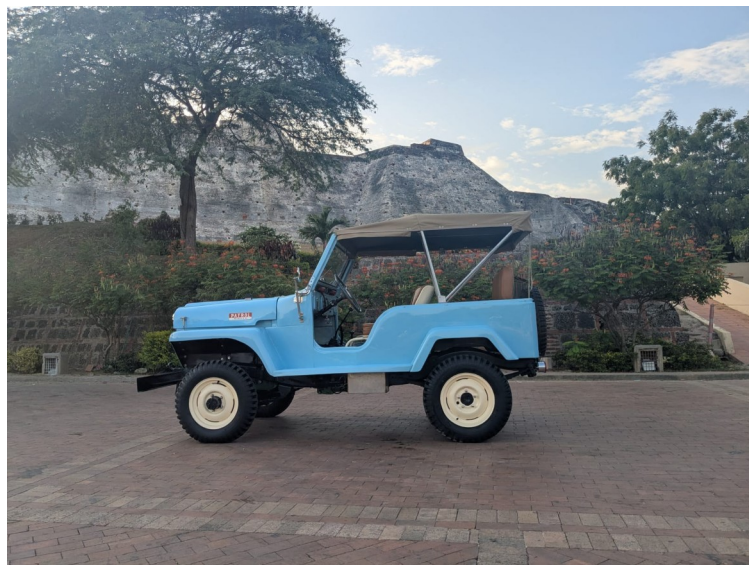
*The finished truck at the Castillo San Felipe, Cartagena (March 2026): Sora Blue over cream 16-inch steel wheels, tan soft top and cowhide interior, replica Nissan Patrol badging.*
